Condition Appraisal – Midtown Parking Structure

WALKER
PARKING CONSULTANTS

PROJECT # 11-2343.00

MAY, 2008

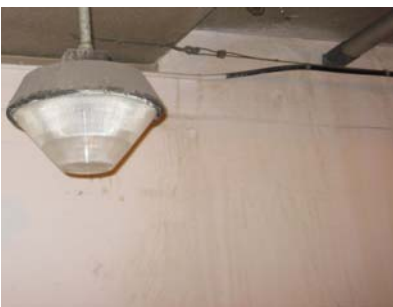
TYPICAL GARAGE LIGHTING FIXTURE IN
PARKING BAYS

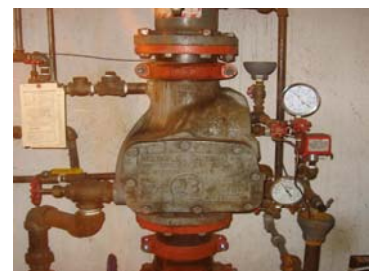
TYPICAL OLD FIRE SPRINKLER MAIN VALVE

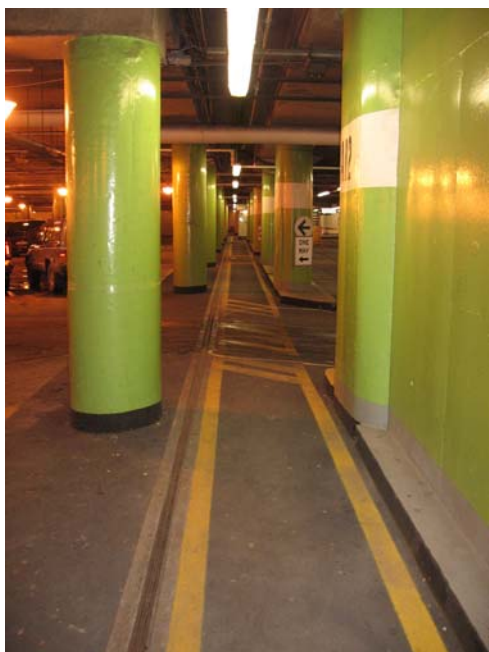
Photo 6 – East/West Expansion Joint

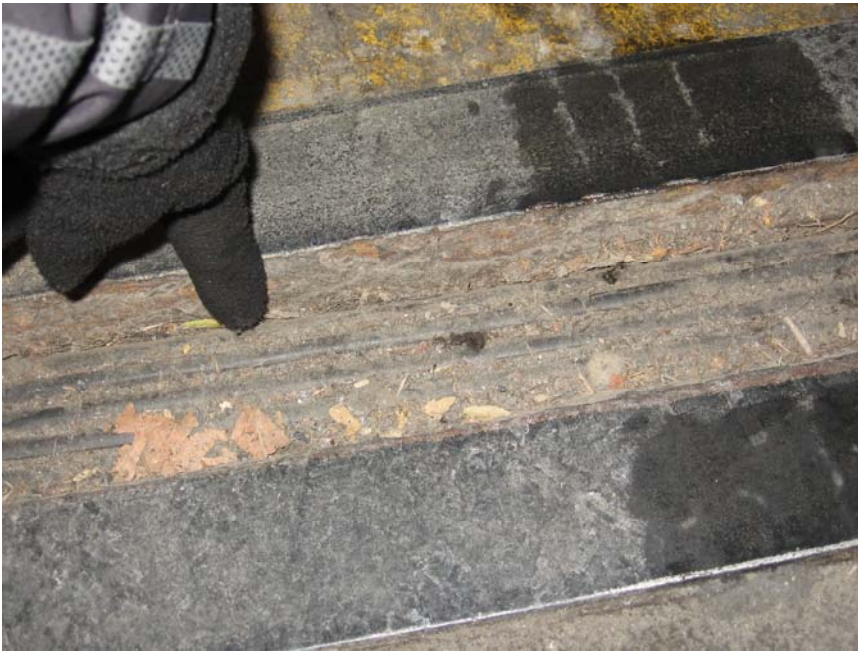
Photo 9 – Typical Expansion Joint System

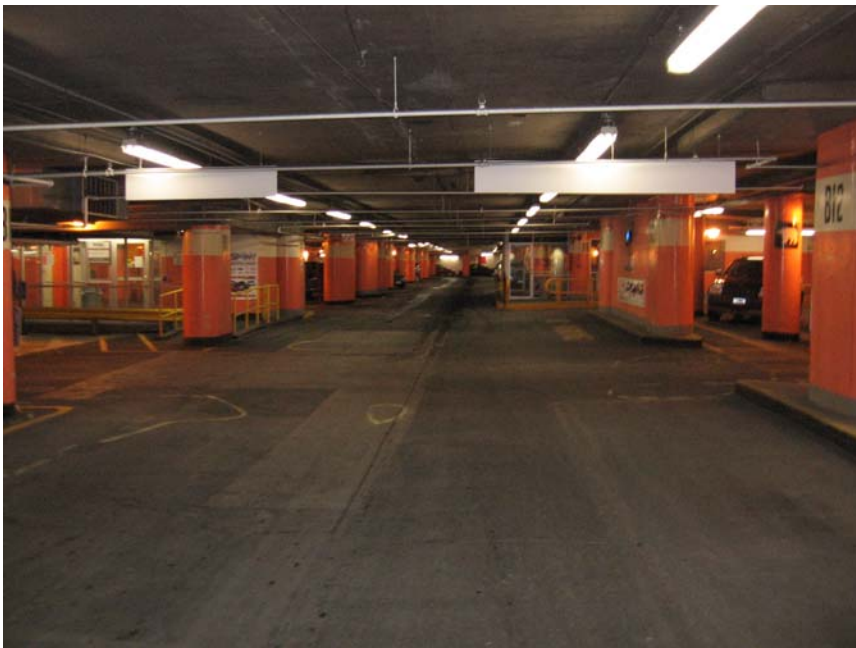
Photo 14 – Main Drive Aisle Area with Asphaltic Coating

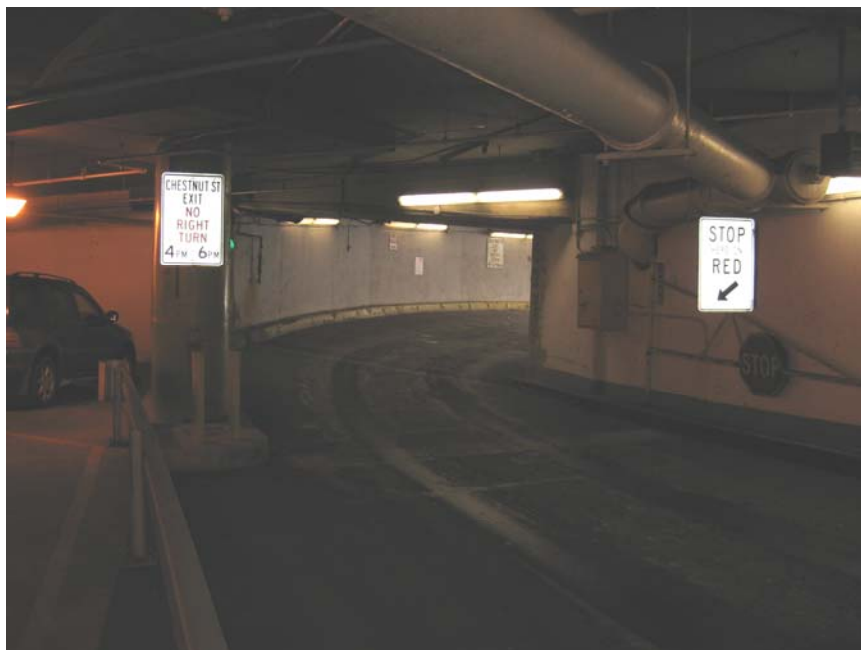
Photo 23 – Exit, Note Asphaltic Coating

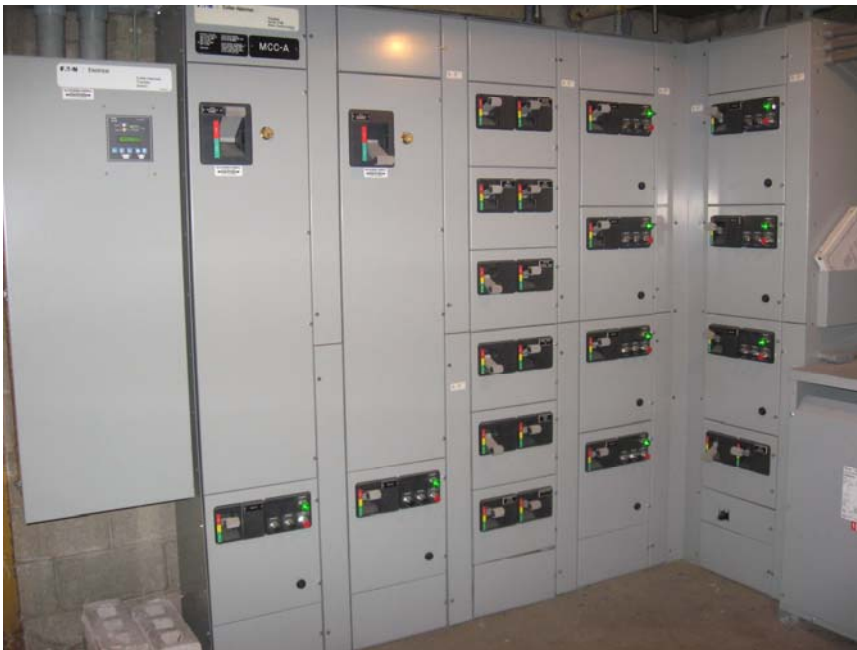
Photo 33 – MCC Electrical Room 204 on Level 'B' Recently Replaced
