WALKER
PARKING CONSULTANTS

CONDITION APPRAISAL

MIDTOWN PARKING STRUCTURE

ROCHESTER, NEW YORK

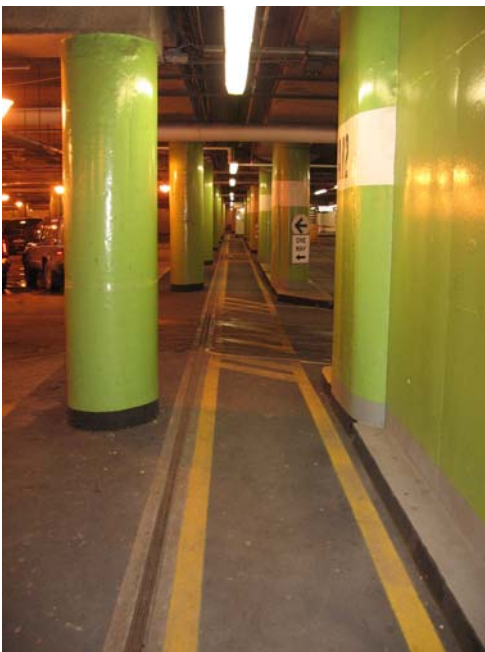
Photo 6 – East/West Expansion Joint

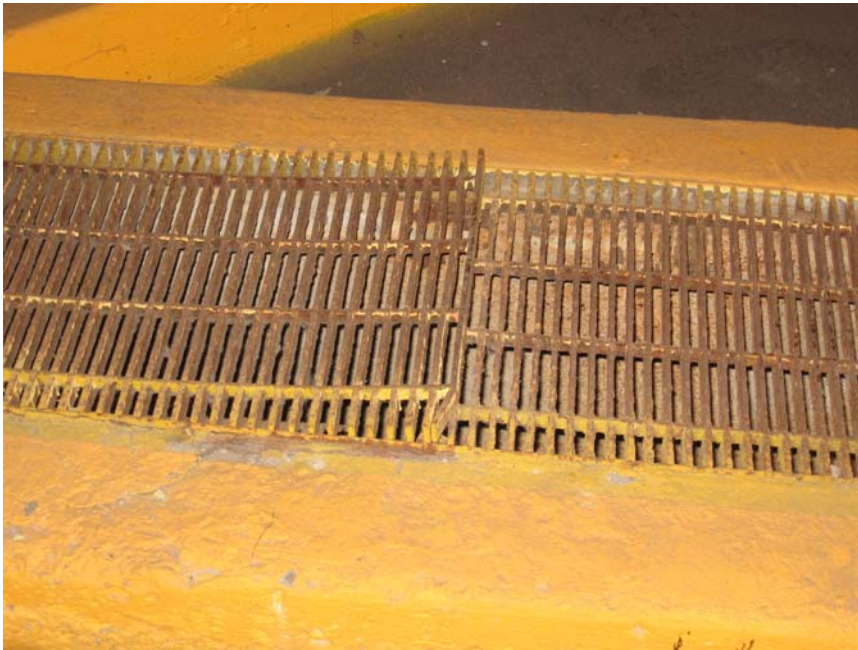
Photo 11 – Exhaust System Grate @ Level C

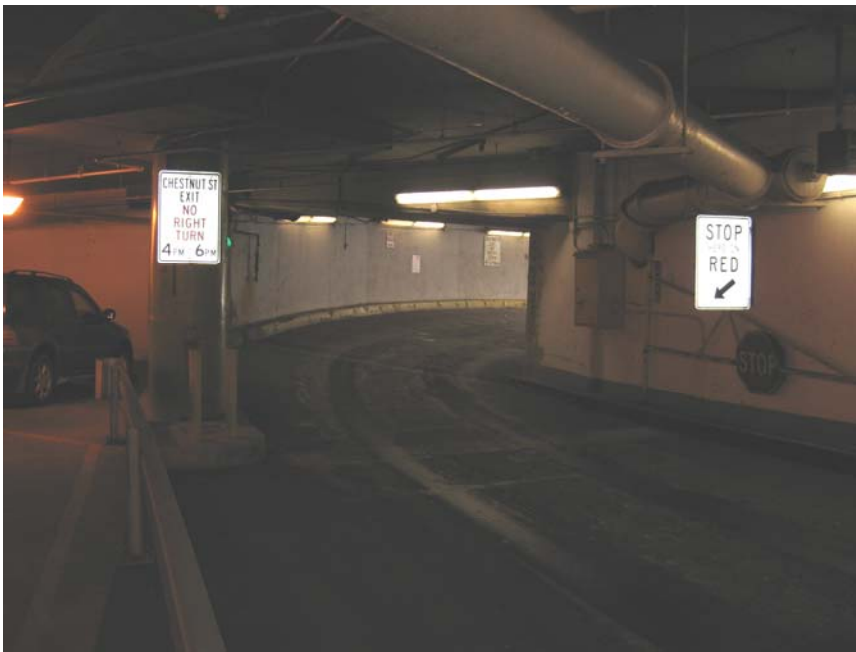
Photo 23 – Exit, Note Asphaltic Coating

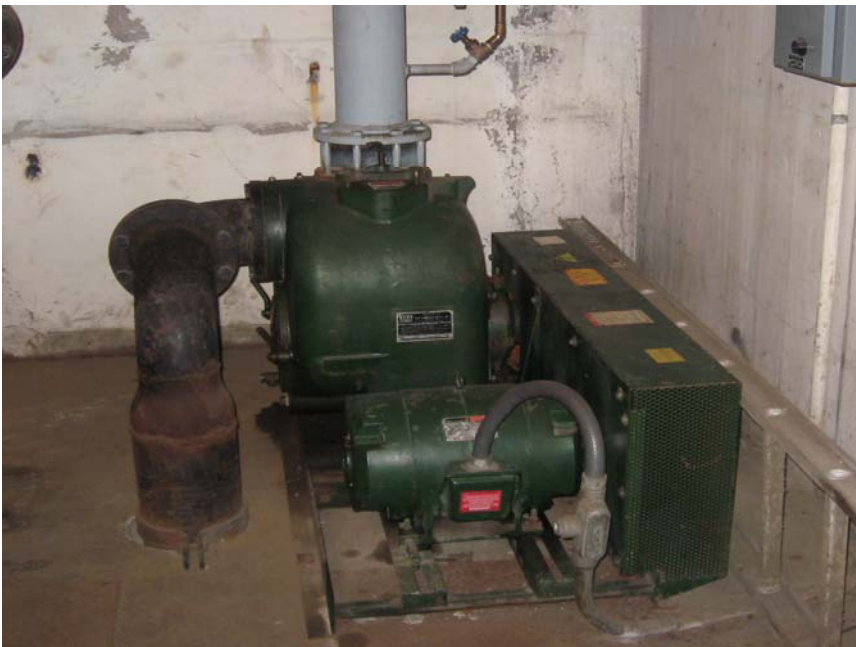
Photo 32 – Sewage Ejector Pump on Level 'C' – One of Two Pumps in this Room

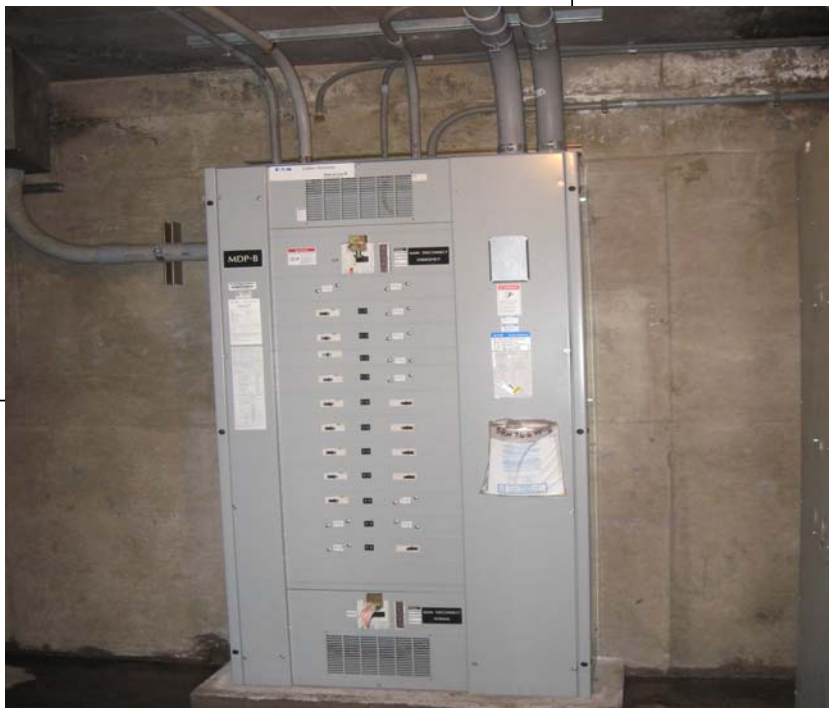
Photo 34 – MDP A in Main Electrical Room on Level 'B' Recently Replaced
