275 ST. PAUL STREET **PRELIMINARY STRUCTURAL ASSESSMENT**

GARDEN AERIAL
MONROE COUNTY, NEW YORK

JUNE 2014

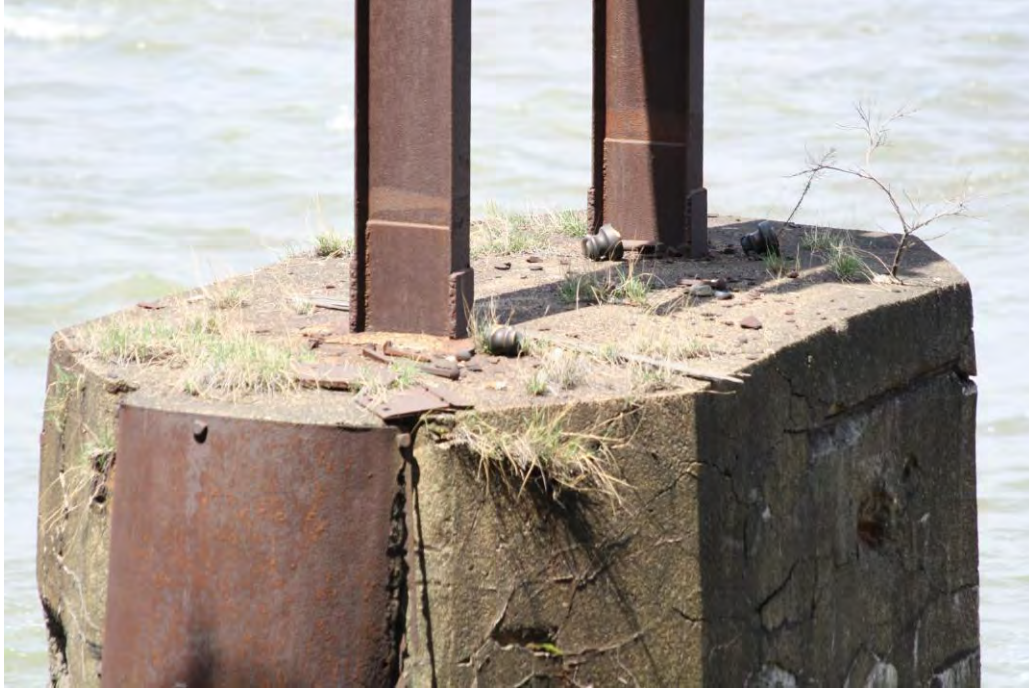
UPPER SECTION OF PYLON SHOWN ABOVE

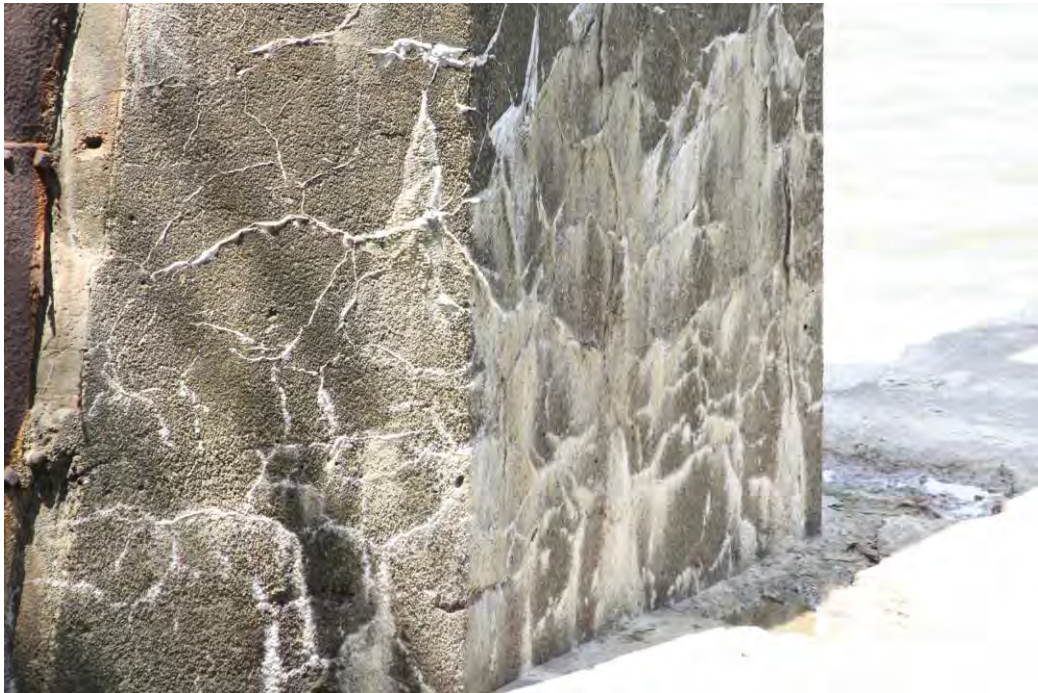
LOWER SECTION OF PYLON SHOWN ABOVE

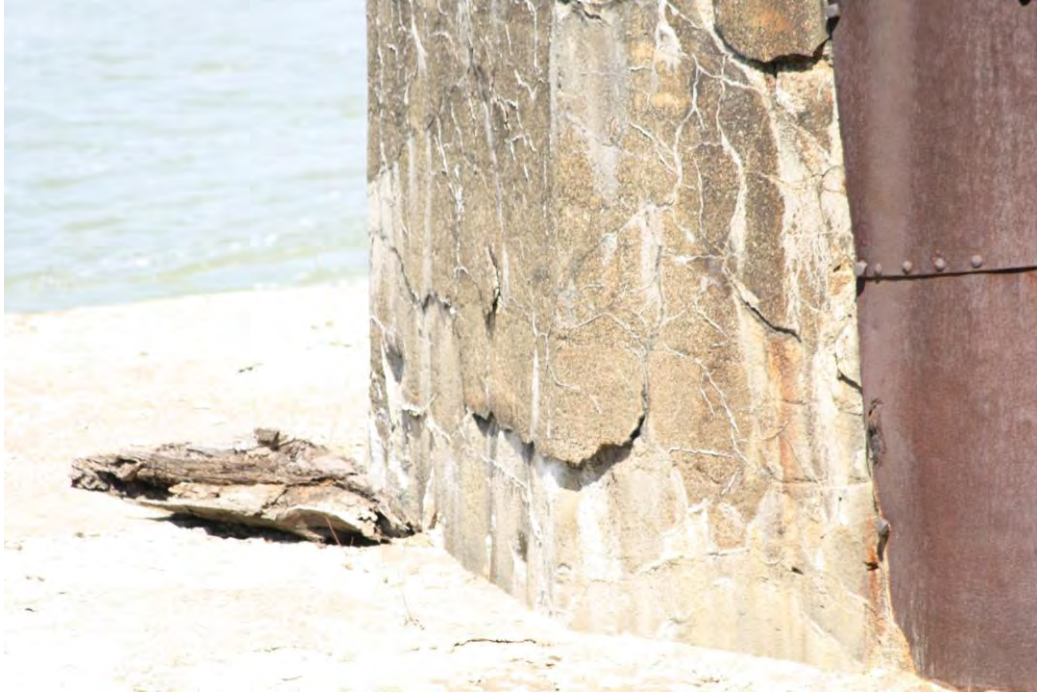
LOWER SECTION OF PYLON 2 SHOWN ABOVE
