The Honorable Loretta C. Scott Center for Human Services Facility Inspection & Repair Design Services

City Bldg. ID No. 9.84 City Project No. 23035

FACILITY CONDITIONS AND NEEDS ASSESSMENT REPORT

Facility Conditions and Needs Assessment Chambers Building

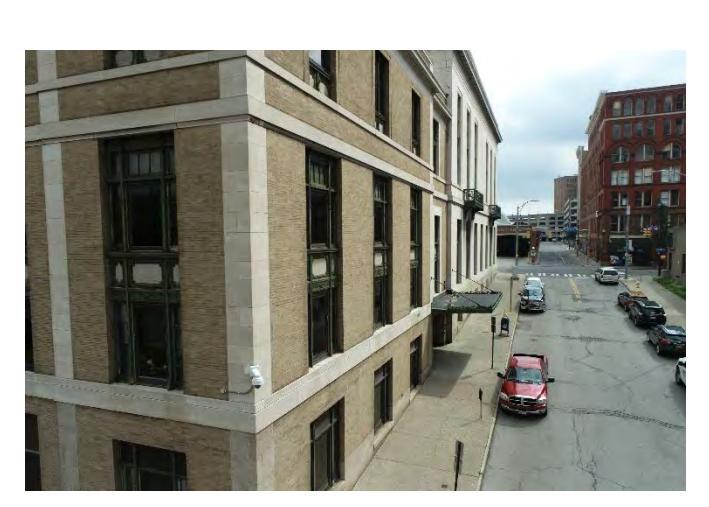
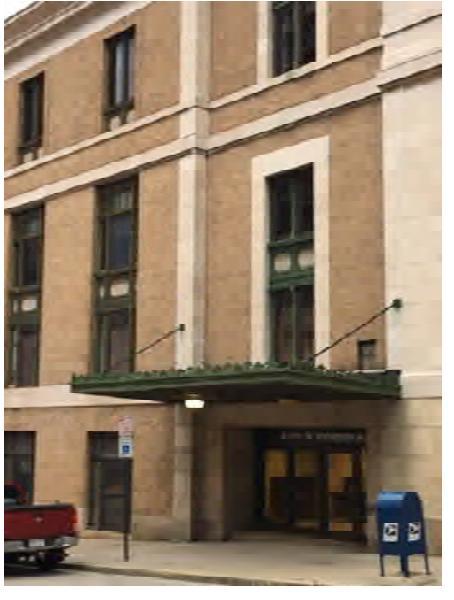
The South side entrance to the building is at grade, on the lower level, and provides a handicap accessible entrance. Currently it is always locked and does not have security posted in the vestibule. This entry provides a handicap accessible route to the west side of the lower level via a wheelchair lift. It also provides handicap access to all the floors above and below via elevator.

Figure – Accessible Entrance (South Side)

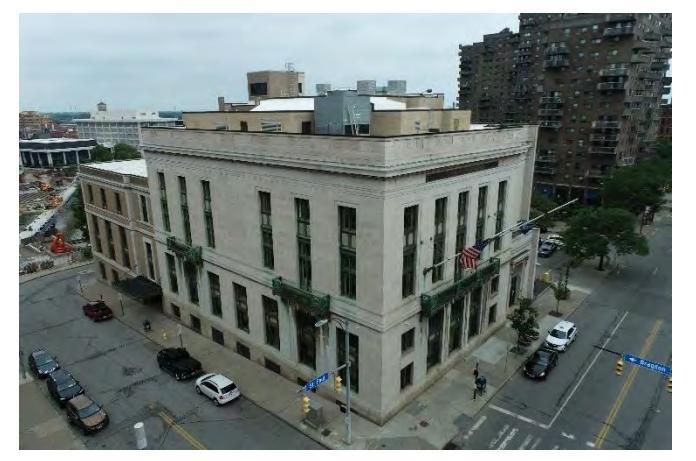
Figure – Southeast Corner CHAMBERS BUILDING ASSESSMENT REPORT – OCTOBER 15, 2021

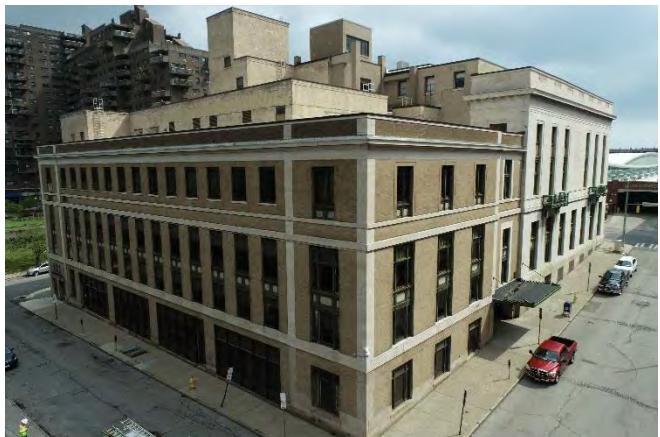
Figure – Southwest Corner

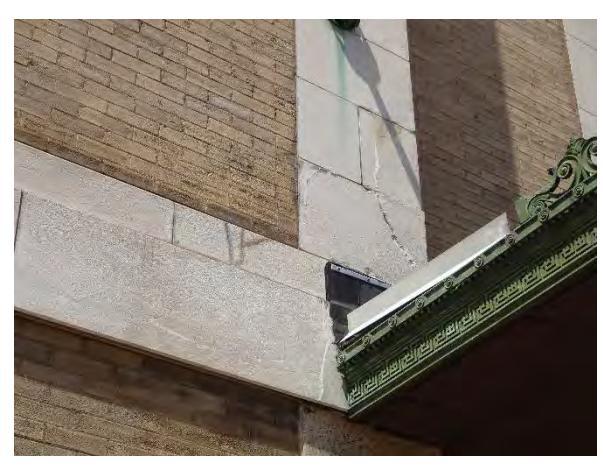
Figure – South Entry Canopy

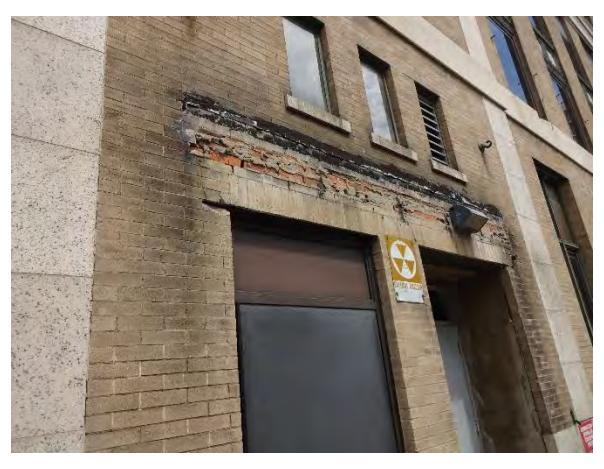
It was observed that a canopy was removed from the building on the northwest corner of the 1925 addition. The brick behind the removed canopy has large gaps in the mortar allowing significant moisture to penetrate the veneer and potentially cause significant rusting of the lintel over the doors. Brick repair, repointing and replacement is needed.

Figure – Brick & Mortar Northwest Corner

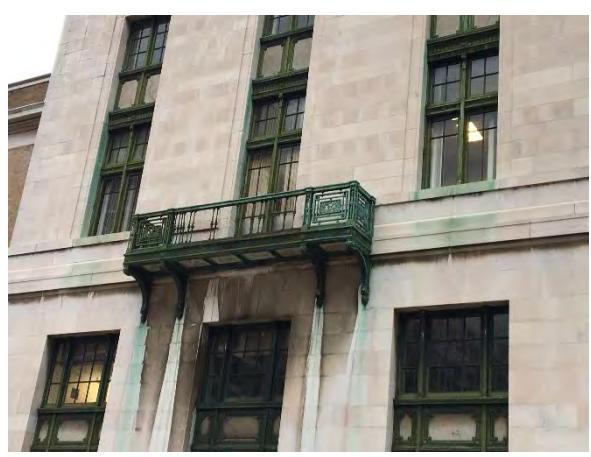
Figure – South Side Balcony

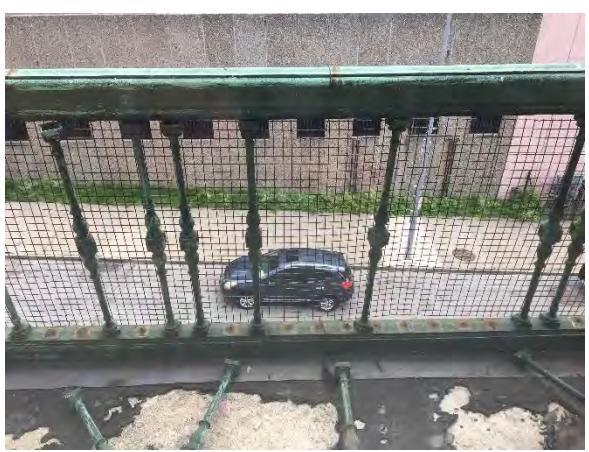
Figure – Balcony

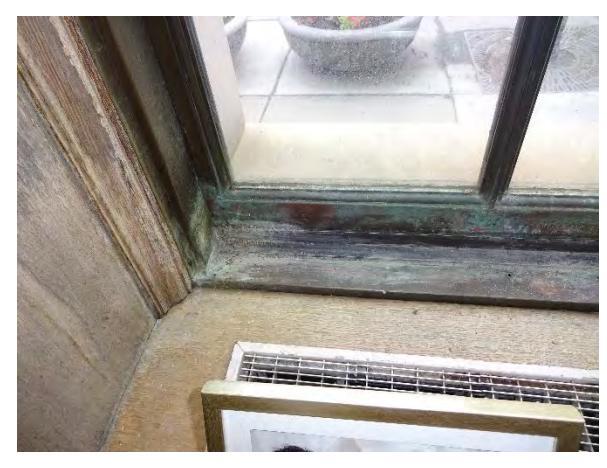
Figure – Interior of 1915 bronze Windows CHAMBERS BUILDING ASSESSMENT REPORT – OCTOBER 15, 2021

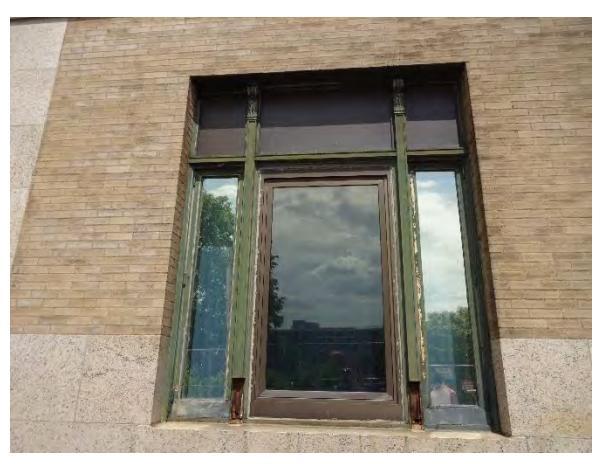
Figure – Window on 1925 Building Addition

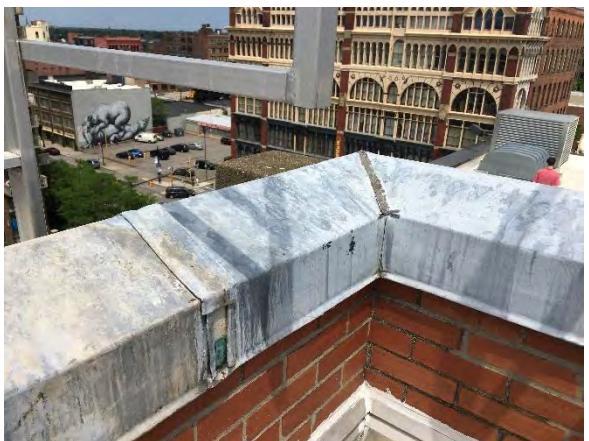
Figure – Coping

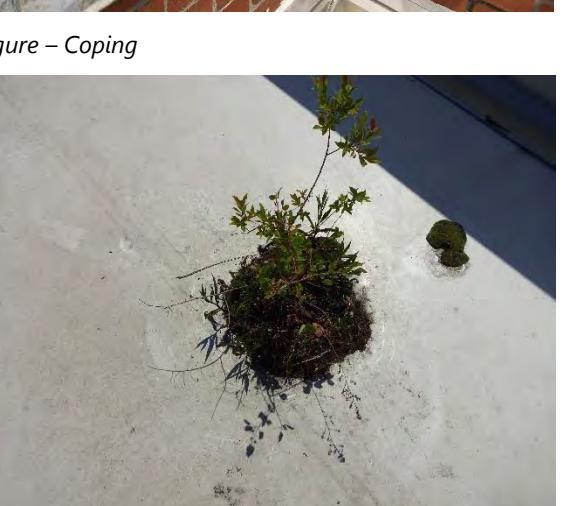
Figure – Vegetation TPO Membrane

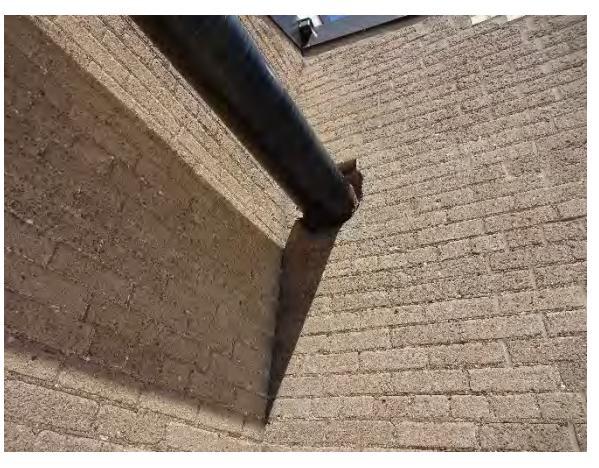
There are several pipe, structural ties/beams, and apparatus items that penetrate the exterior walls at roof level. These penetrations are not sealed around the penetration, whether by lack of installation or wear of the installed sealants. These penetrations need to be resealed to prevent water, air, and vermin infiltration and destruction.

Figure – Wall Penetration at Roof Level

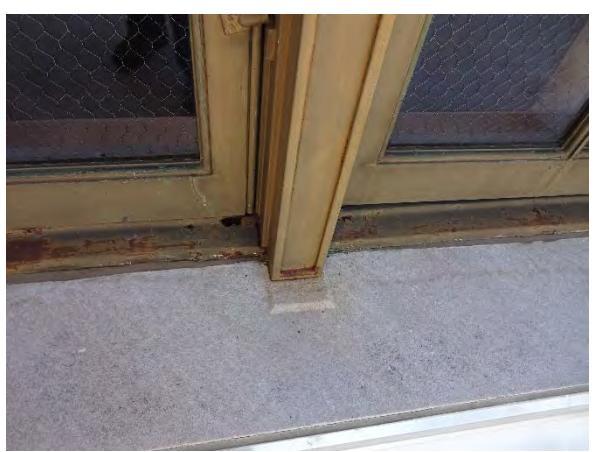
Figure – Window at Roof level

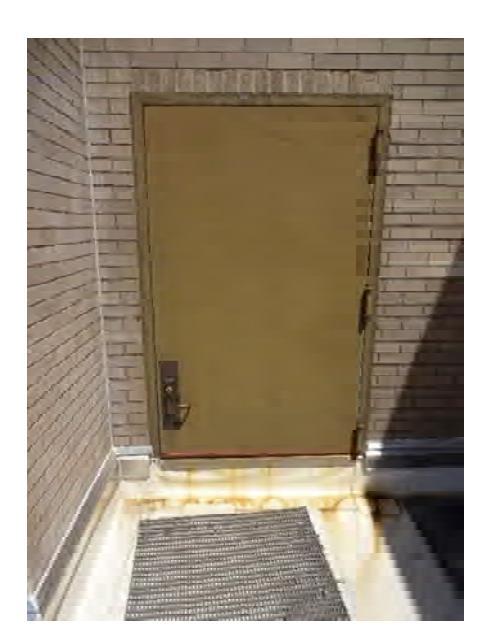
Figure – Roof Access Door

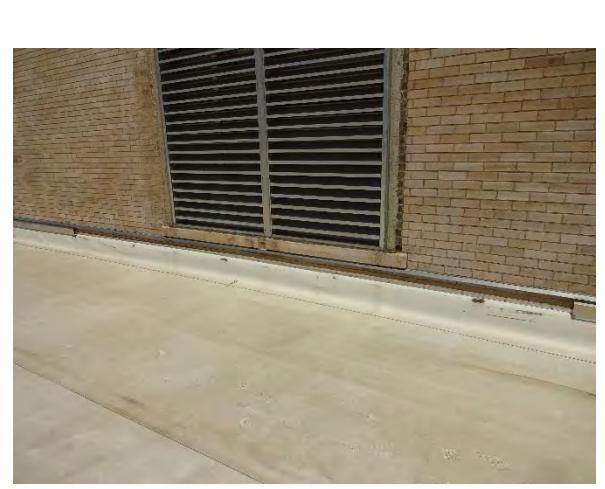
Figure – Missing Reglet

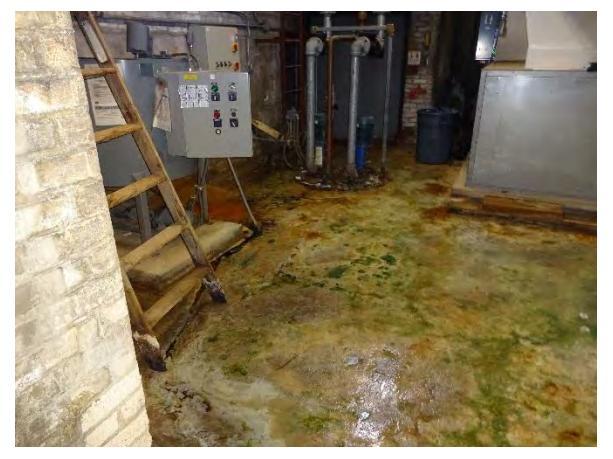
Figure – Standing Water in Sub-Basement

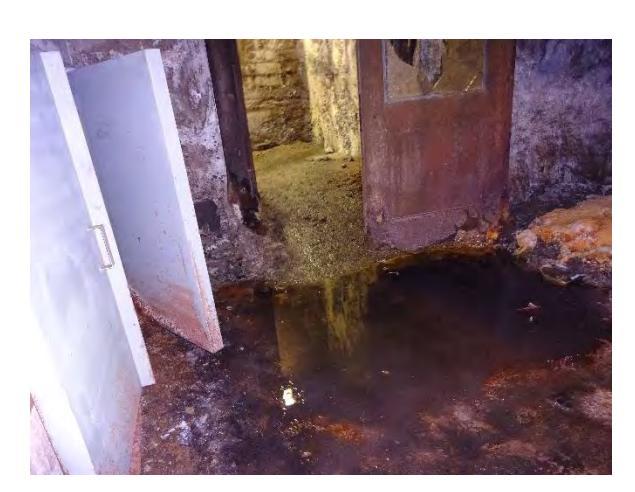
Figure – Standing Water in Sub-Basement

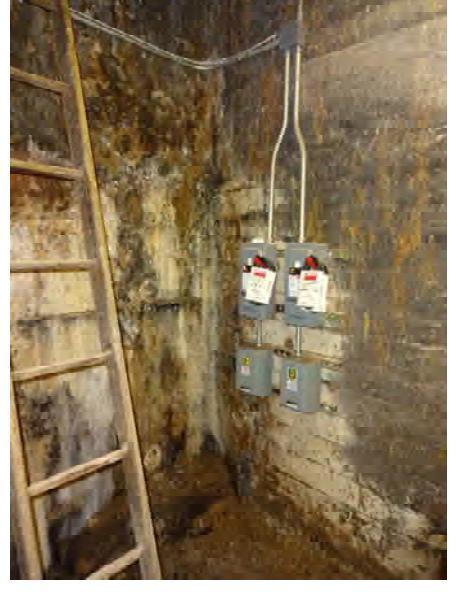
Figure - Water Intrusion at Electrical Switches

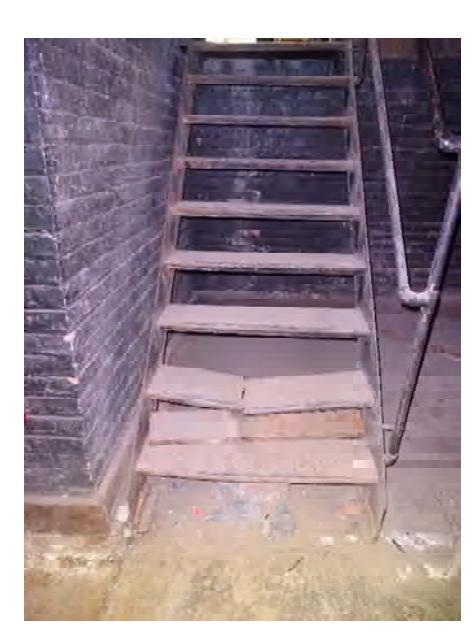
Figure – Brocken Steel Tread

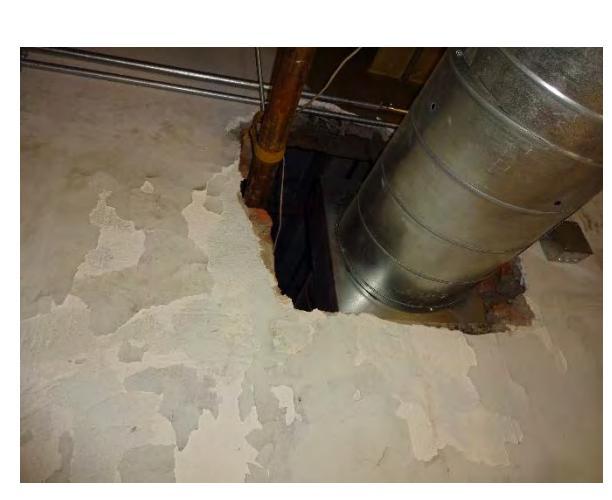
Figure – Mechanical Room Through Wall Penetration

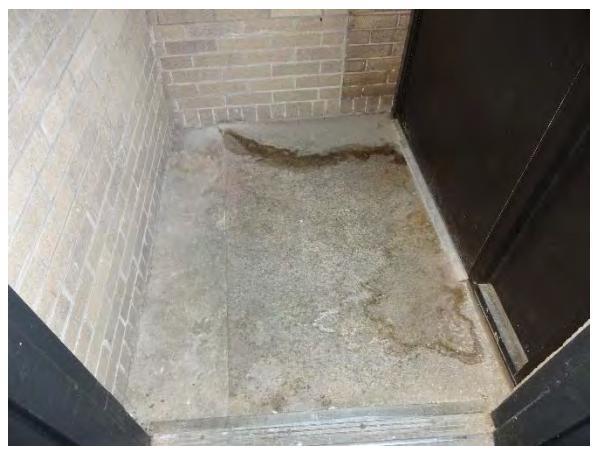
Figure – Water Intrusion at Exterior Door (West Side)

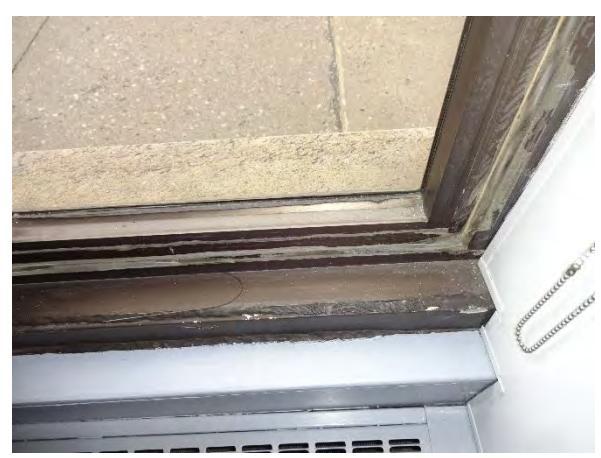
Figure – Interior Window (West Side)

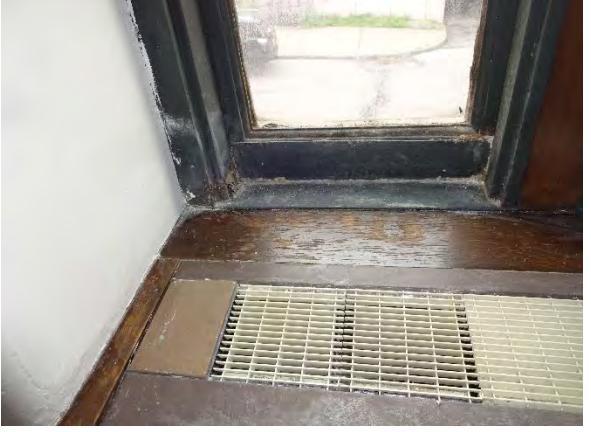
Figure – Interior Window Condition (1925 Addition)

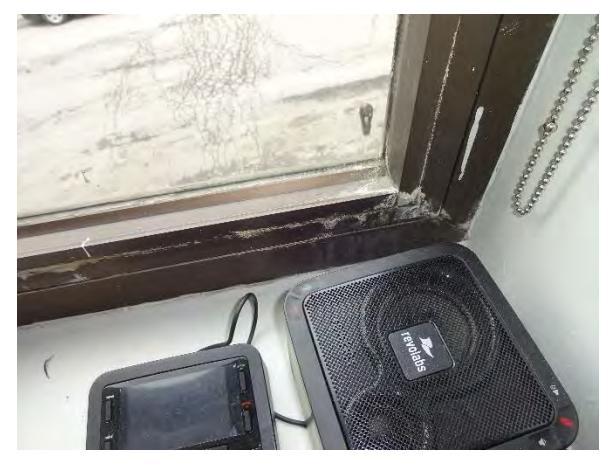
Figure – Interior Window Condition (1925 Addition)

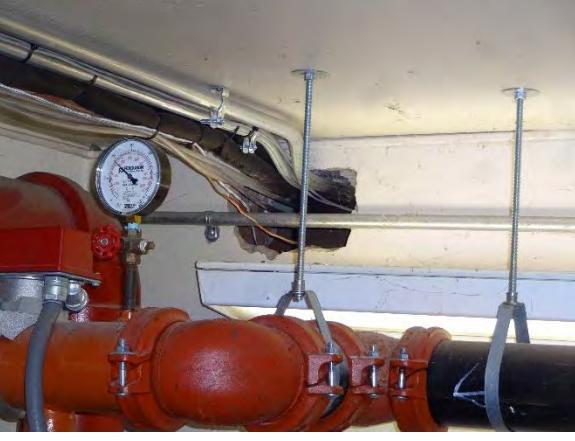
The existing Stairwell is a rated enclosure, and any penetrations must maintain the rated enclosure. There are conduits penetrating the stair wall that must be fire stopped to maintain the rated enclosure.

Figure – Through Wall Penetration at Stair A

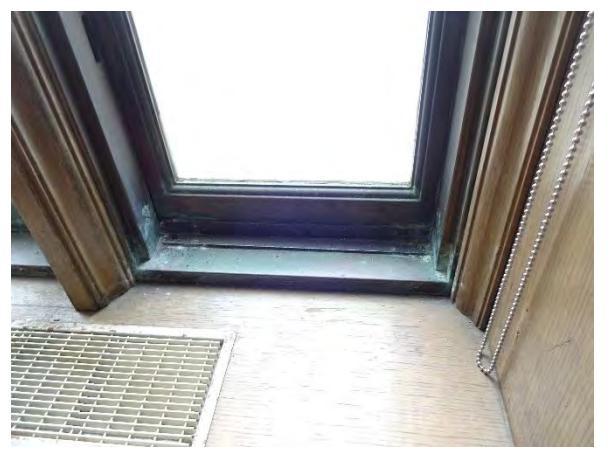
Figure – Interior Window Condition (1915 Building)

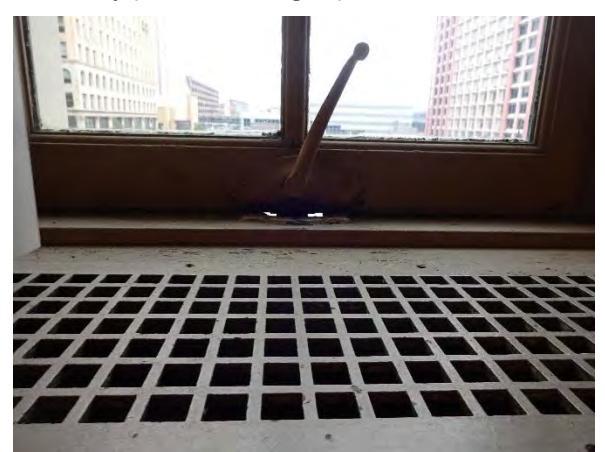
Figure – Interior Window Condition (1915 Building)

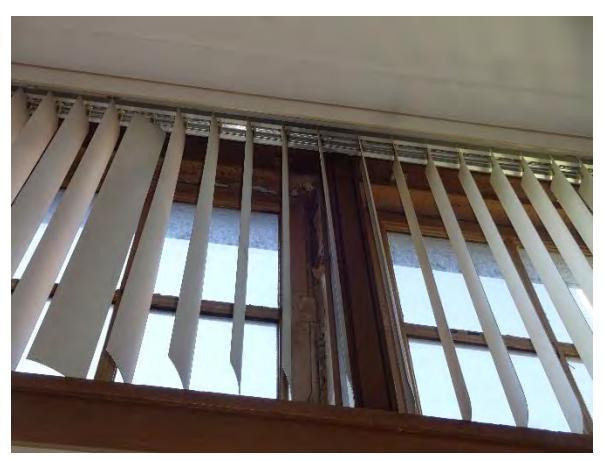
Figure – Interior Transom Windows (1915 Building)

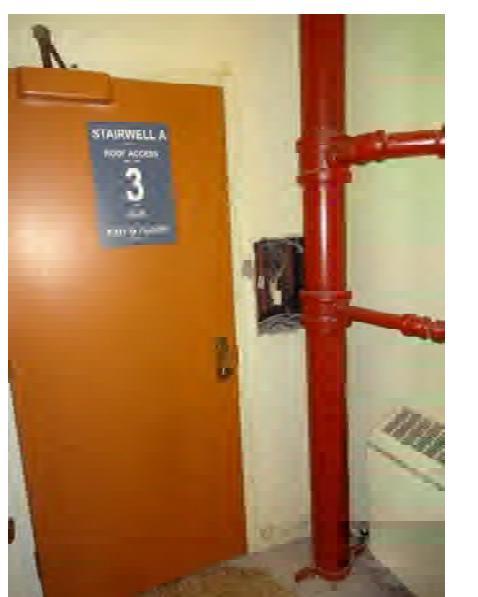
Figure – Through Wall Penetration

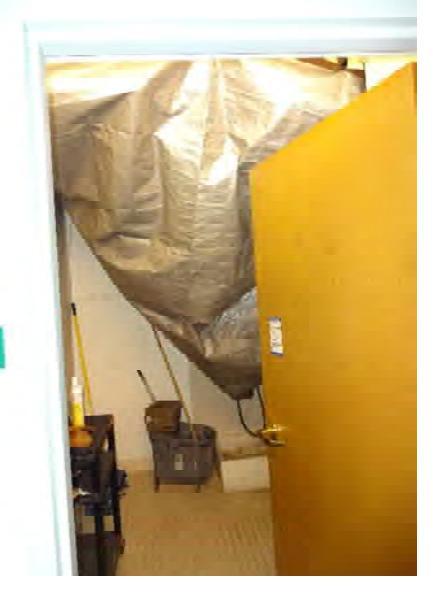
There is significant ceiling damage from a water leak above. Investigation of the cause of the water leak is necessary prior to ceiling repair.

Figure – Janitor's Closet

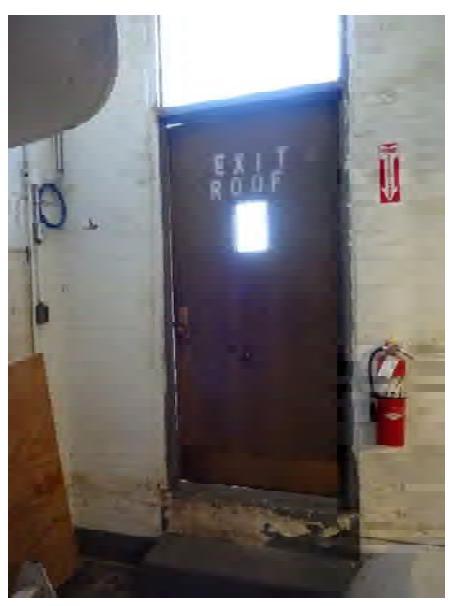
Figure – Roof Access Door

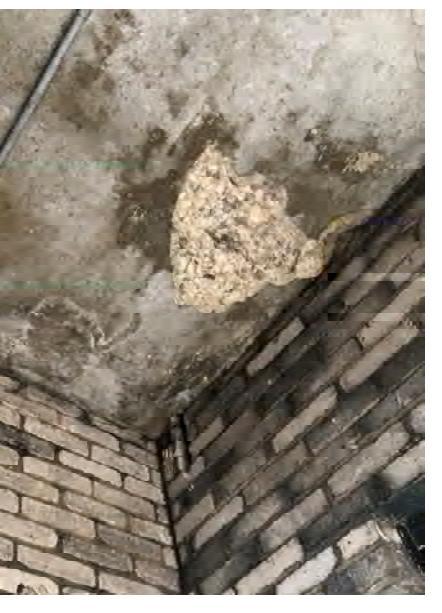
Along the underside of the exterior overhang located along the east side of the building, just west of the parking lot, there is visible concrete spalling and cracking visible. These areas of concrete should be repaired using an injectable mortar or epoxy (i.e. Hilti Cl 060 Crack Injection System or similar) to fill any visible cracking and a bonding agent (i.e. Sika Armatec 1C or similar) and concrete repair mortar (i.e. Sika Repair 223 or similar) to patch the areas of spalling concrete. It is important to repair any exterior deterioration to reduce the risk of moisture infiltration into the building, and in the case of spalled concrete to reduce the risk of the concrete reinforcement corroding when exposed to the exterior elements.

Figure – Spalled Concrete at Concrete Overhang (0183)

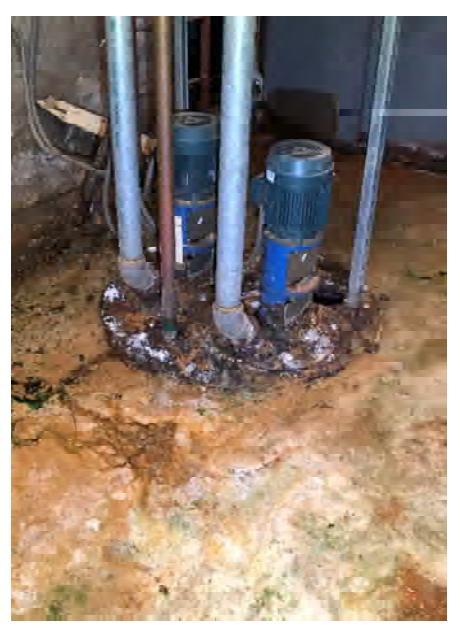
Figure – Existing Sump Pump in Basement (0001)

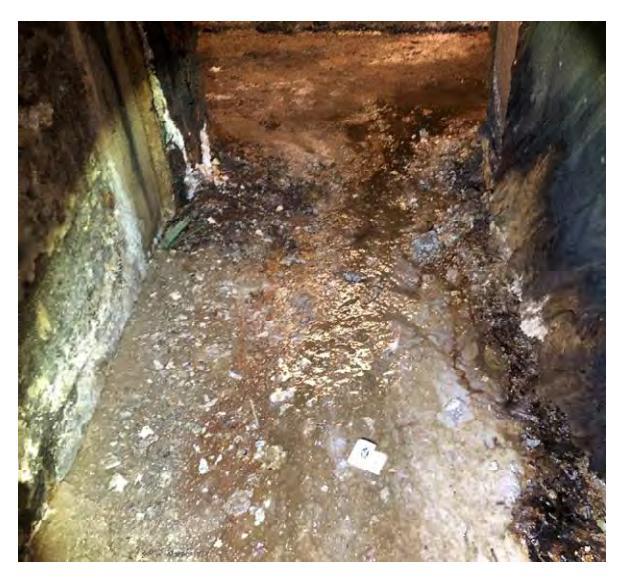
Figure – Water along Basement Floor (9984)

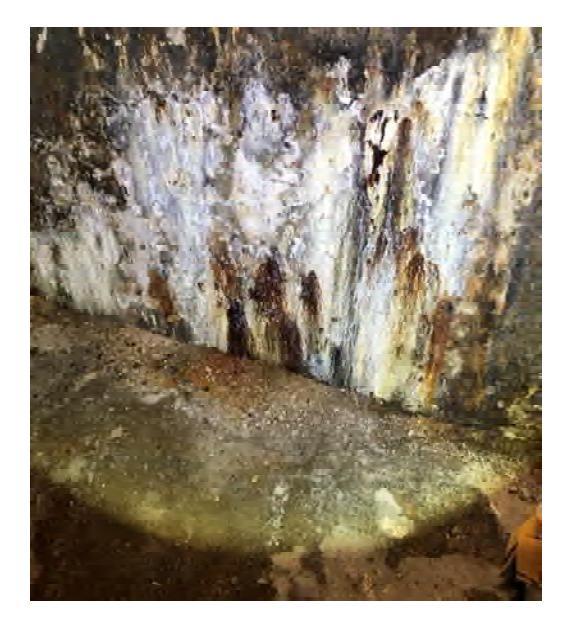
Figure – Water Running along Basement Wall (9973)

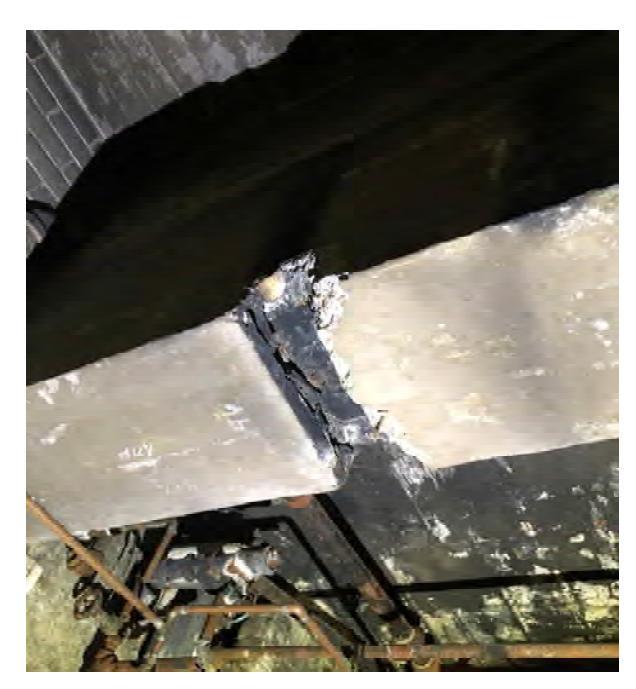
Figure – Portion of Removed Concrete Encasement (0024)

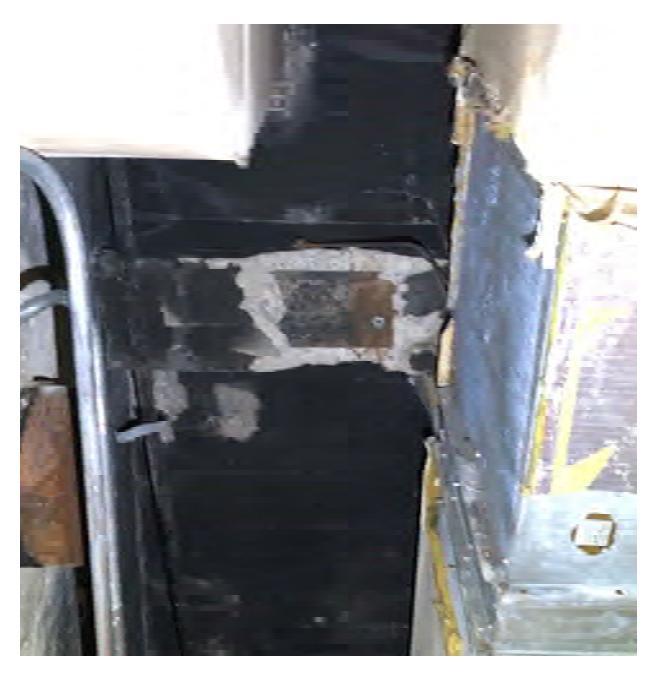
Figure – Portion of Removed Concrete Encasement (0025)

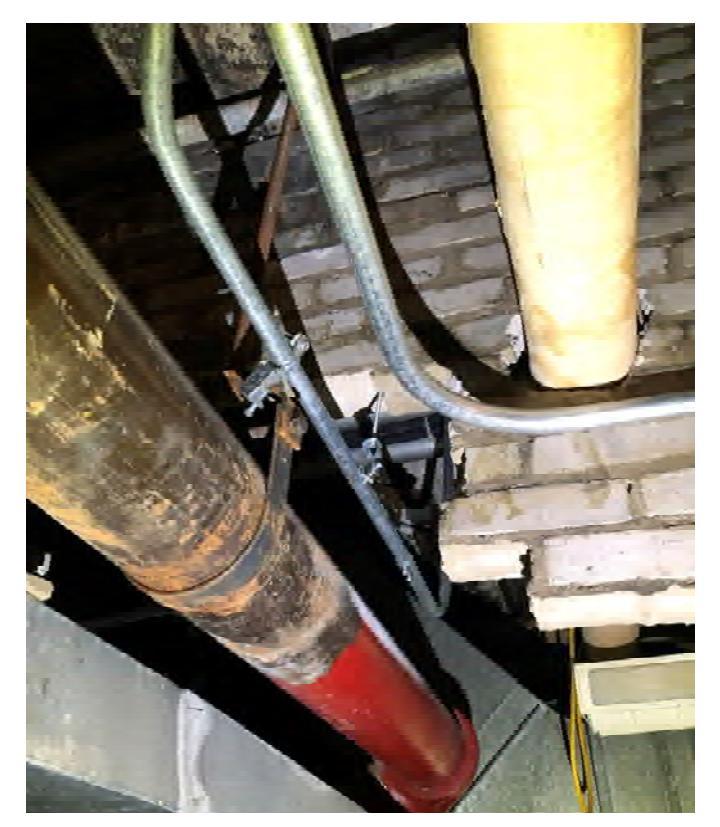
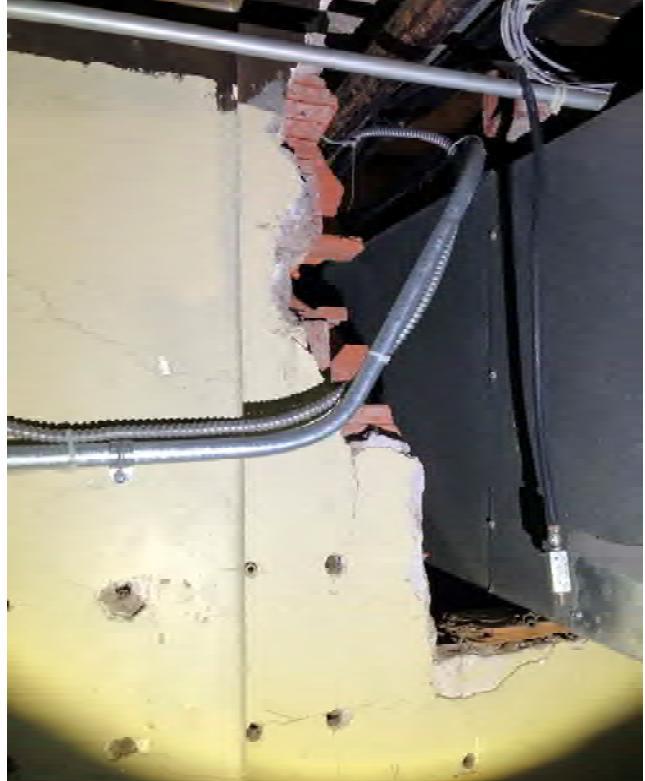
There are a few locations throughout the lower level where penetrations through masonry walls for ductwork do not include any sort of steel lintel support over the wall penetration. The masonry above the opening is unsupported; therefore, it is recommended that new steel angles be provided as lintels spanning over the wall penetration and providing proper load path to transfer the weight of the masonry wall above the opening to the adjacent portions of wall on either side of the wall opening. All caulks, mortars, concrete patches, sealants, and plaster wall materials impacted by masonry support installation will require sampling and analysis for asbestos or be assumed as asbestos containing.

Figure – Unsupported Masonry Wall Penetration (0055)

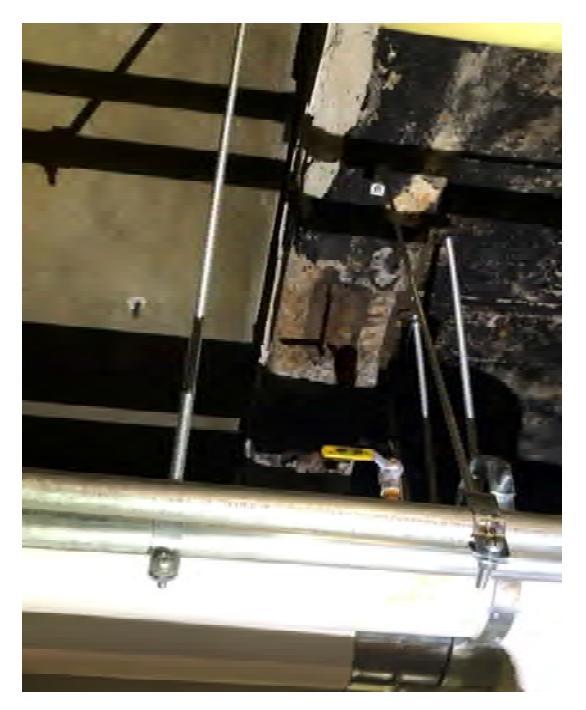
The typical concrete encasement around a few of the steel structural beams has been removed to allow for steel hangers and overhead utility support framing to be easily welded to the steel superstructure. This concrete acts primarily as a form of fireproofing for the steel superstructure, so it needs to be restored. A concrete repair product (i.e. Sika Repair 223 or similar) shall be used to infill all portions of concrete encasement that have been removed.

Figure – Portion of Removed Concrete Encasement (0056)

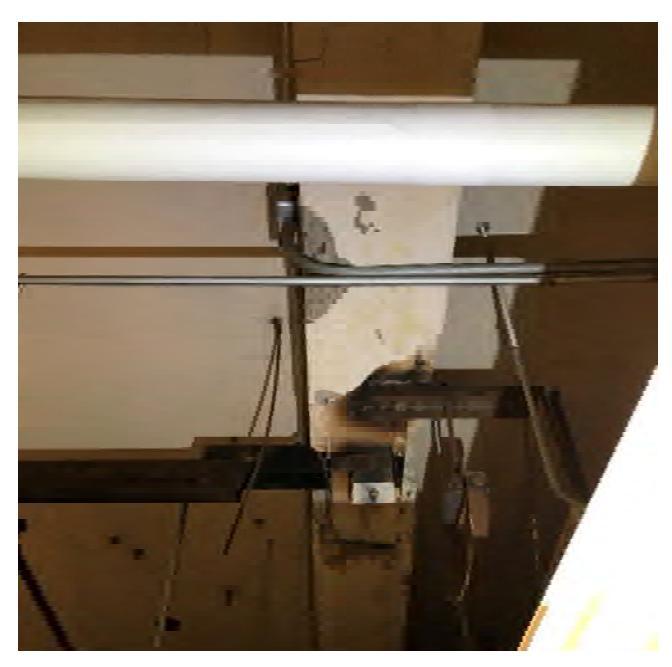
The typical concrete encasement around many of the steel structural beams has been removed at numerous locations to allow for steel hangers and overhead utility support framing to be easily welded to the steel superstructure. This concrete acts primarily as a form of fireproofing for the steel superstructure, so it needs to be restored. A concrete repair product (i.e. Sika Repair 223 or similar) shall be used to infill all portions of concrete encasement that have been removed. LBP may be present on the surface of these concrete encasements.

Figure – Portion of Removed Concrete Encasement (0099)

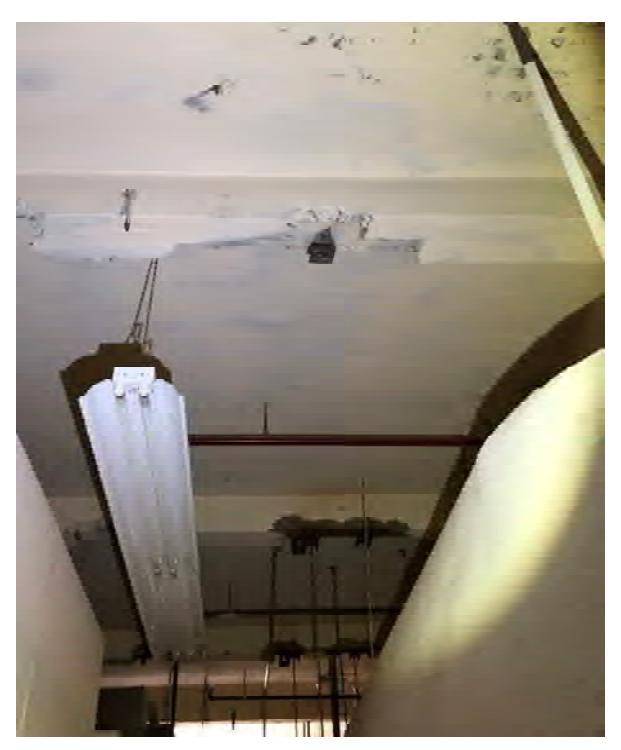
Figure – Portions of Removed Concrete Encasement (0102)

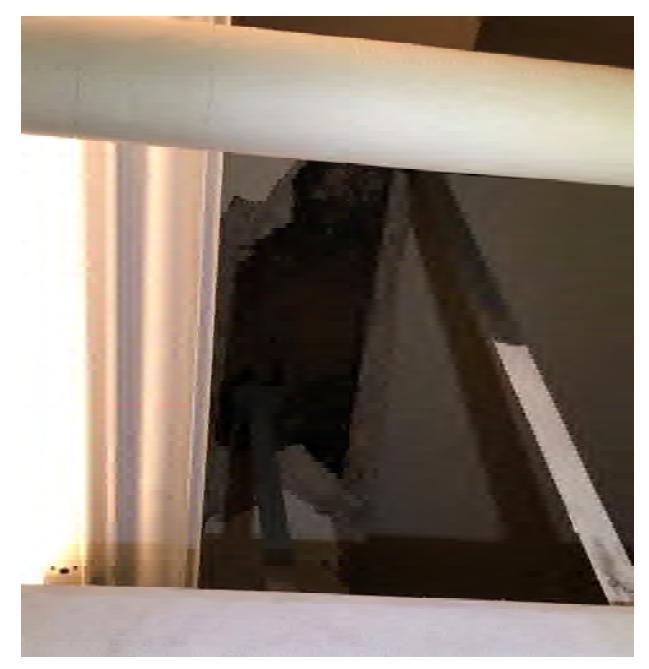
Figure – Portion of Removed Concrete Encasement (0100)

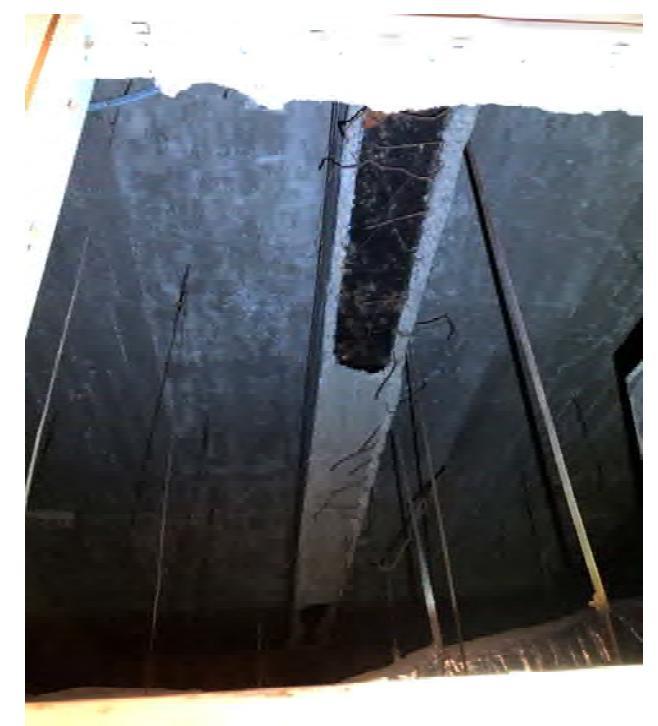
Figure – Portion of Removed Concrete Encasement (0105)

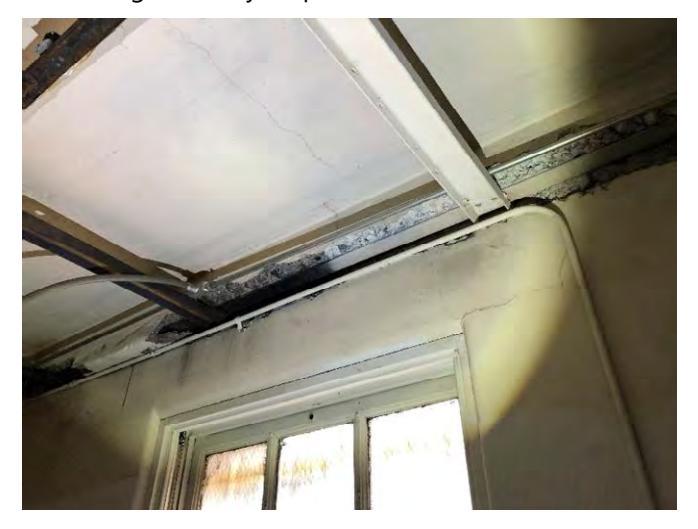
The typical concrete encasement around many of the steel structural beams has been removed at numerous locations to allow for steel hangers and overhead utility support framing to be easily welded to the steel superstructure. This concrete acts primarily as a form of fireproofing for the steel superstructure, so it needs to be restored. A concrete repair product (i.e. Sika Repair 223 or similar) shall be used to infill all portions of concrete encasement that have been removed. All caulks, mortars, concrete patches, sealants, and plaster wall materials impacted by encasement repair will require sampling and analysis for asbestos or be assumed as asbestos containing. LBP may be present on the surface of these concrete encasements.

Figure – Portion of Removed Concrete Encasement (0152)

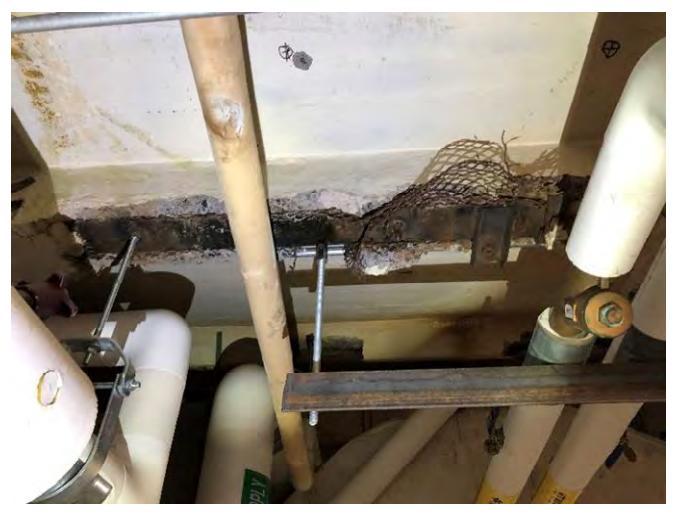
Figure – Portion of Removed Concrete Encasement (1054)

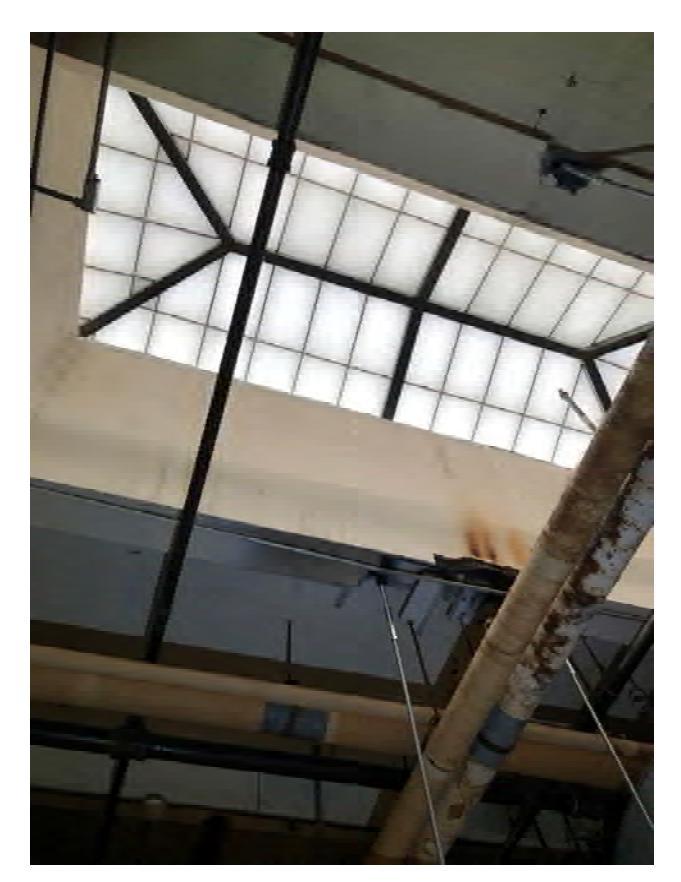
Figure – Portion of Removed Concrete Encasement (0160)

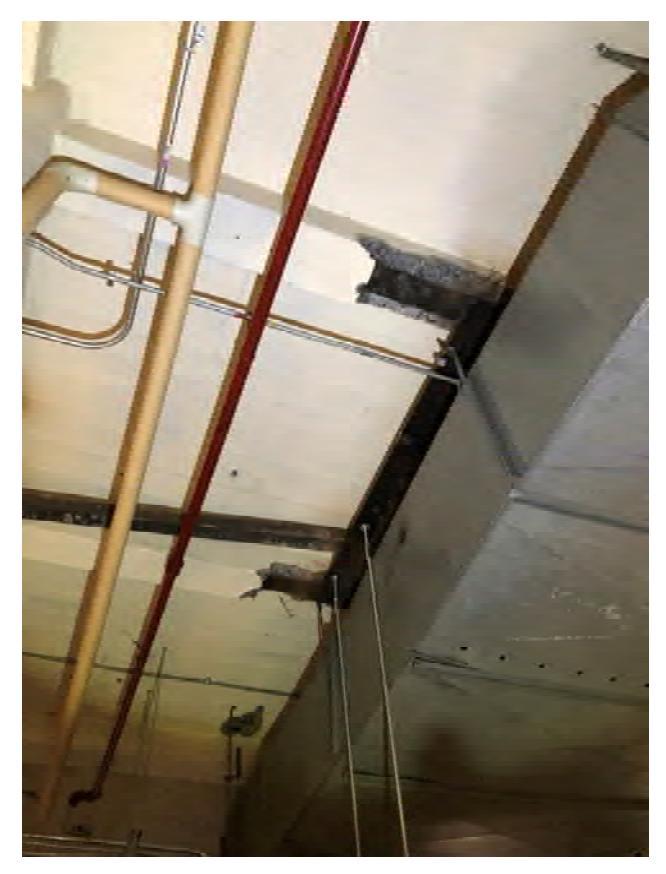
Figure – Portion of Removed Concrete Encasement (0169)

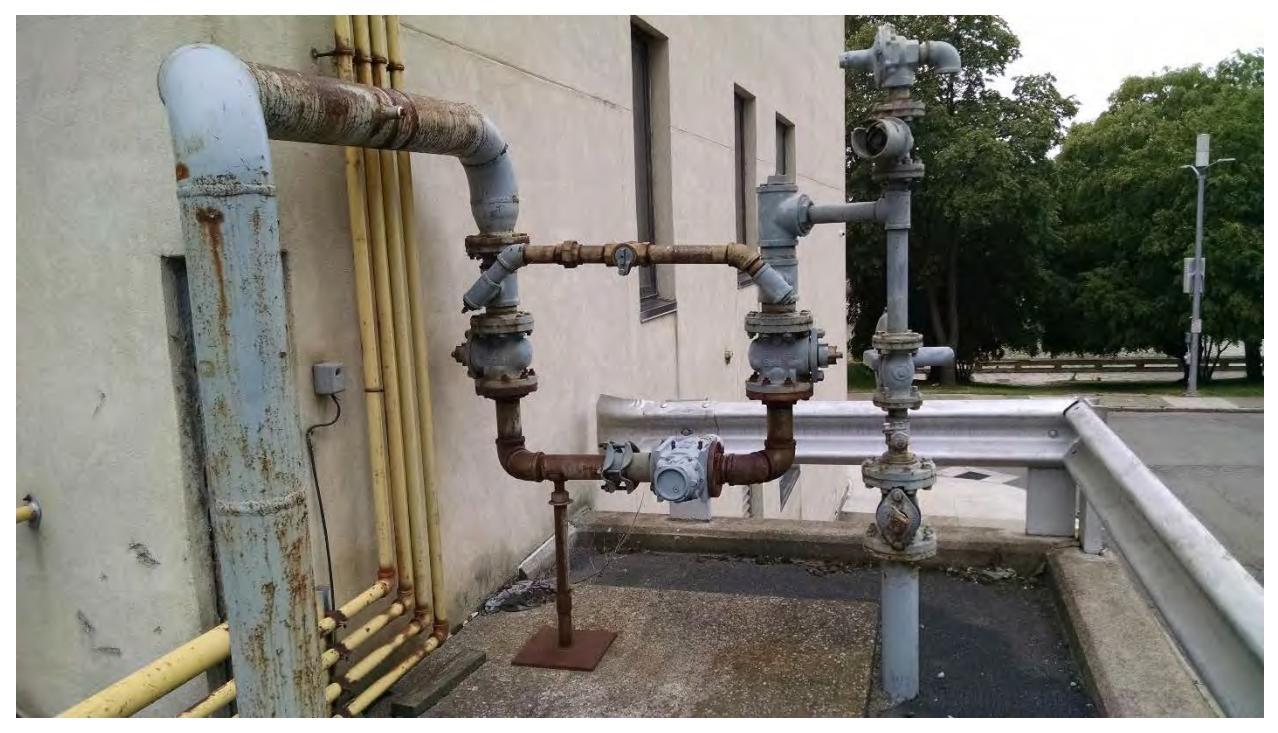
A 4-inch high pressure gas line serves the building. The gas meter and regulator assembly are located outside on the northeast corner of the 1925 addition. There is a roots style flow meter with a capacity of 5,000 cfh. A 6-inch line enters the building through the former coal storage bin under a part of the parking lot. From here it serves the equipment in the boiler room including the two hot water boilers and the domestic hot water tank. Parts of this line are not painted and are suffering from significant corrosion.

Figure: Natural gas service

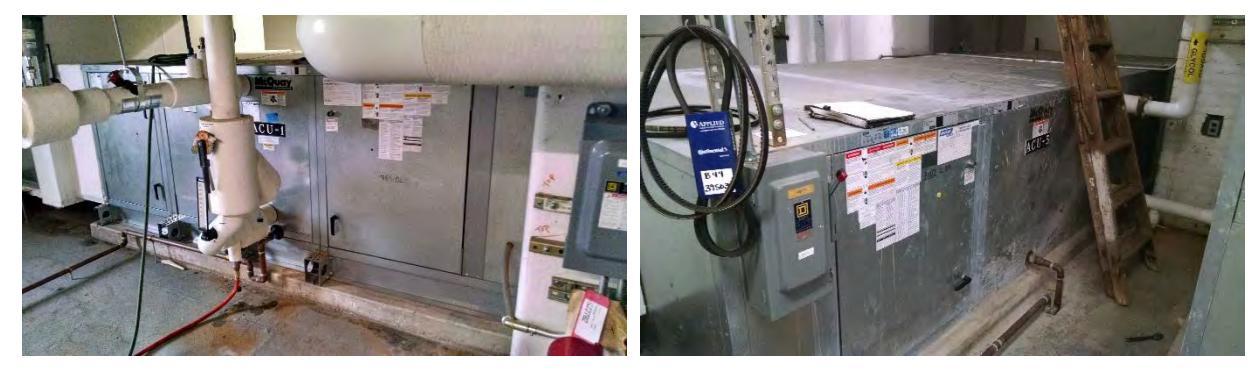
All of the McQuay ACUs appear to have been installed about 2009 and are in average condition. They still have a reasonable service life ahead. The Trane unit appear to be in the best condition and may be newer. The Carrier unit (ACU-8) located in the boiler room, is the oldest unit and is in the poorest condition. It also suffers from being in the very wet boiler room space.

Figure: ACU-1

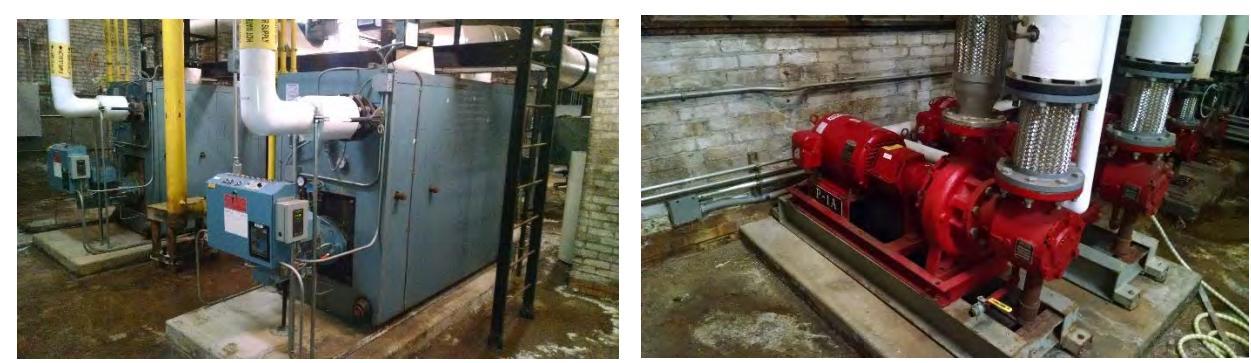
The breeching is in good condition with proper insulation. There are draft controllers on each boiler but it is not known how functional they are. The drains from the boilers are very corroded at the end of the line. The natural gas piping is in good condition where painted but showing corrosion where the lines have not been painted.

Figure: Existing Hot Water Boilers

Figure: Existing hot water pumps
