The Honorable Loretta C. Scott Center for Human Services Facility Inspection & Repair Design Services

City Bldg. ID No. 9.84 City Project No. 23035

FACILITY CONDITIONS AND NEEDS ASSESSMENT REPORT

Facility Conditions and Needs Assessment Chambers Building

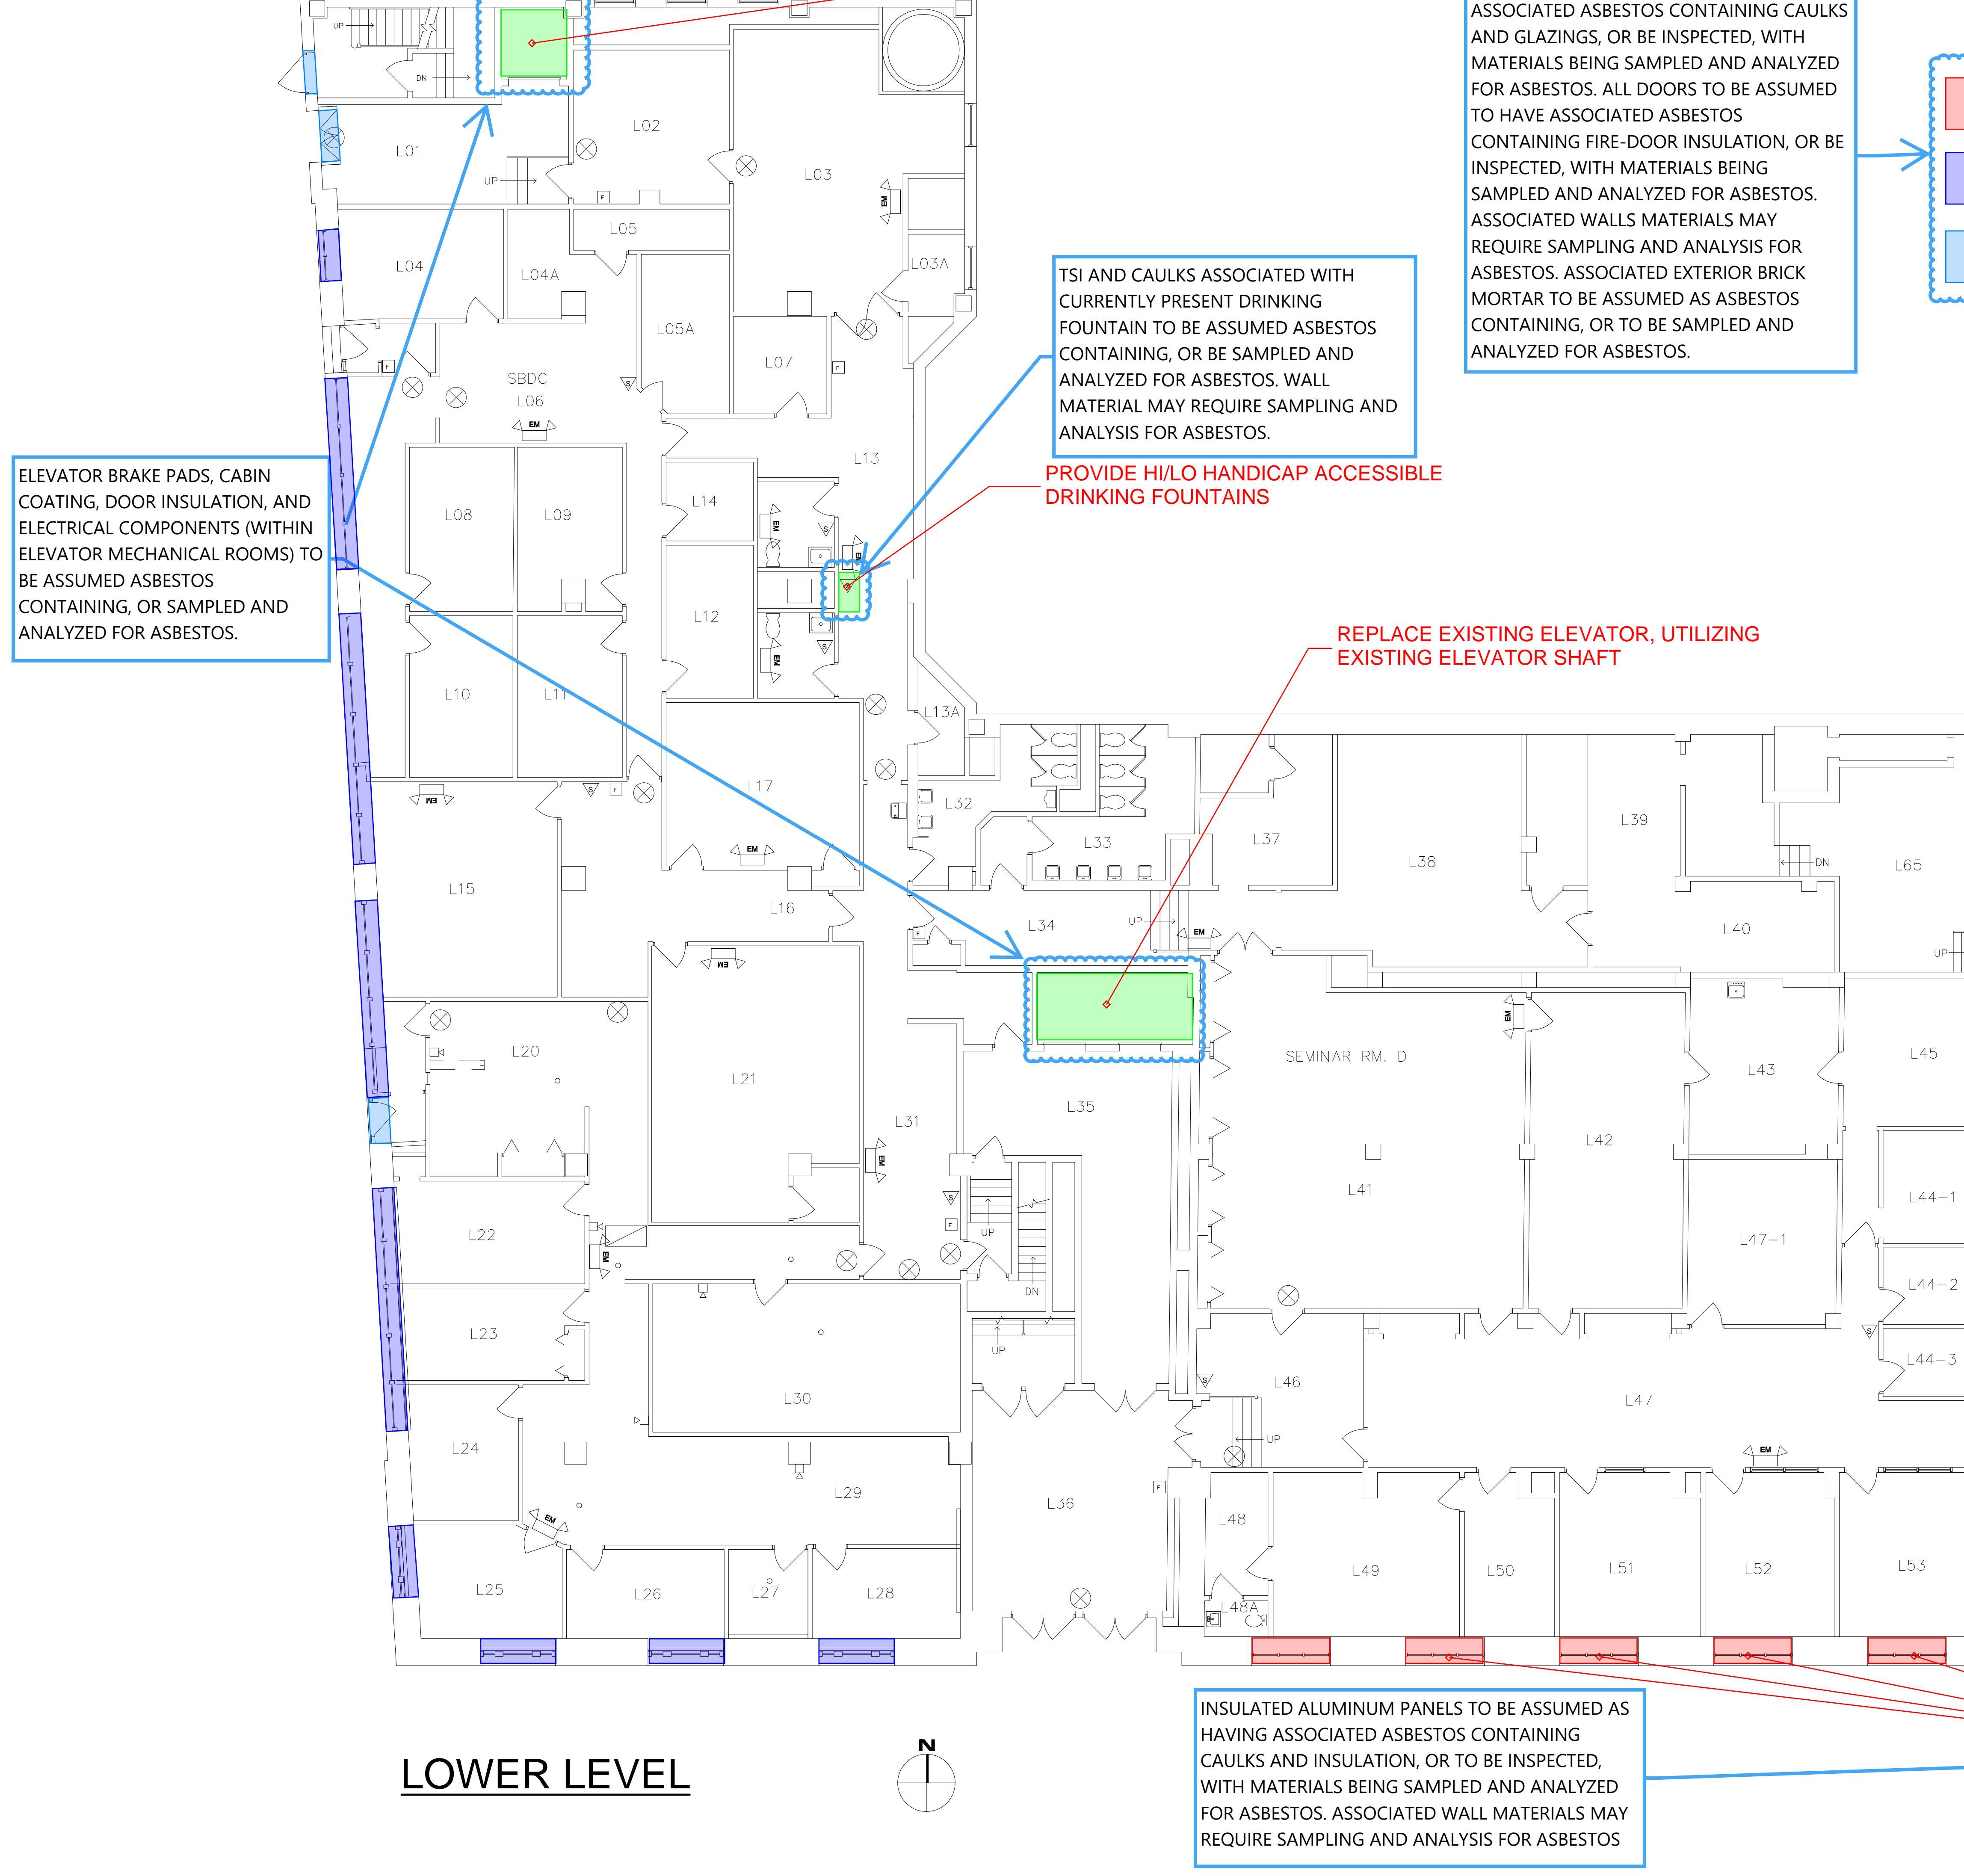
STAIR INTO MECHANCAL ROOM. REPLACE STAIR TREAD. \otimes DN -L64 EXCAVATE ALONG EAST SIDE OF MECHANICAL ROOM AND INSTALL WATERPROOFING ALONG EXTERIOR OF BASEMENT FOUNDATION WALL. COATINGS AND CAULKS ASSOCIATED WITH EXTERIOR OF BASEMENT FOUNDATION WALL L61 TO BE ASSUMED ASBESTOS CONTAINING, OR TO BE SAMPLED L60 AND ANALYZED FOR ASBESTOS. \otimes L59 L58 L56 L55 L54 **REPLACE INSULATED** ALUMINUM PANELS

REPLACE EXISTING FREIGHT ELEVATOR,
